FORM B - BUILDING

HNS.223

Address: 671 Indian Head Street

Historic Name: Pamela Howland House/Allan
and Joanne Clemons House

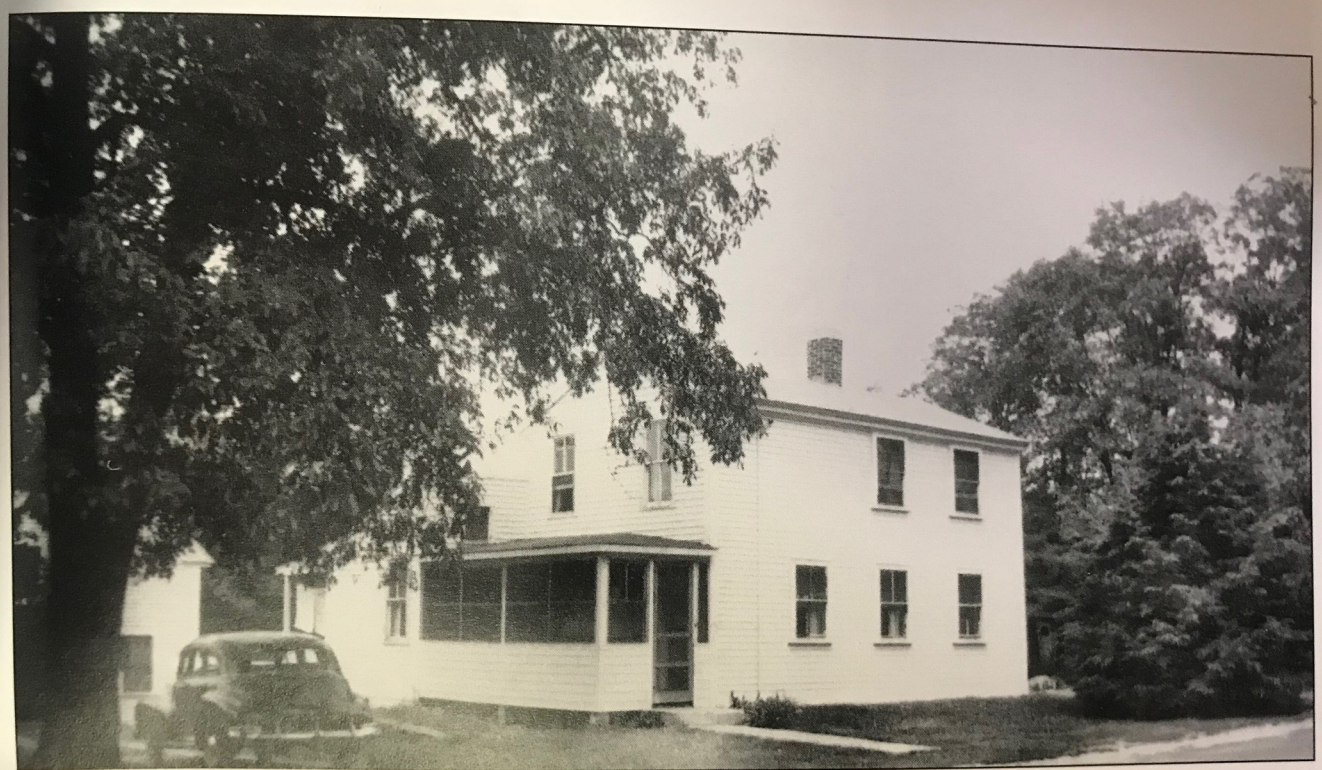
Ca. 1940 photo of 671 Indian Head Street from *Images of Hanson*, Page 49.

This home was originally built in the center of Pembroke in the early 1800s. It was moved in 1860 to its present location, at 671 Indian Head Street, by Pamelee Howland. This picture was taken in 1940. Allan Clemons enlarged and remodeled the home between the years 1962 and 1980.

A ca. 1940 photograph of the house gives a sense of the extent to which the building has been altered over time. The existing first bay and front entrance in the southeast corner of the house are not present in this photo. Instead, a low one-story screened porch covers part of the original south façade, behind which is a lean-to shaped addition leading to what appears to be the current south entry to the house. The house had two-over-two windows at this time and one of the existing windows was then missing from the southeast corner of the second floor. The existing barn is visible to the west of the house.
